Manhole Inspection Summary

Manhole # S33EE1002MH

Location Address: **3800 39TH ST**

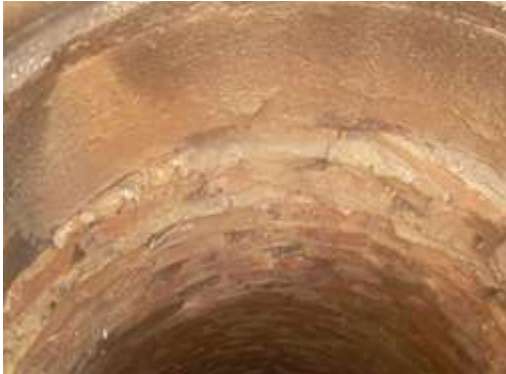
Defect

frame leaks and infiltration

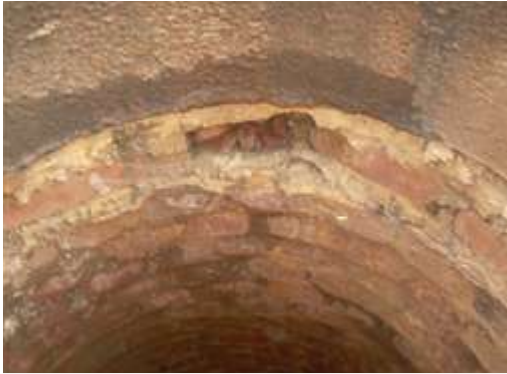
Defect

frame leaks deteriorated chimney

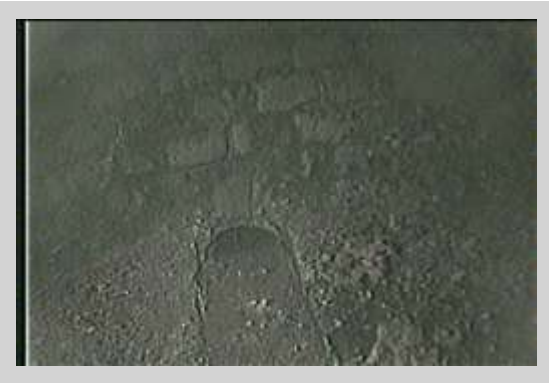
8 in. Circular Gravity Sewer Pipe Out @ 12 O'Clock

Deposits: ☐ None ☐ Mud ☐ Sludge ☒ **Debris** ☐ Grease

Silt Depth: **4** (in.) Deposits Extent: **Heavy**

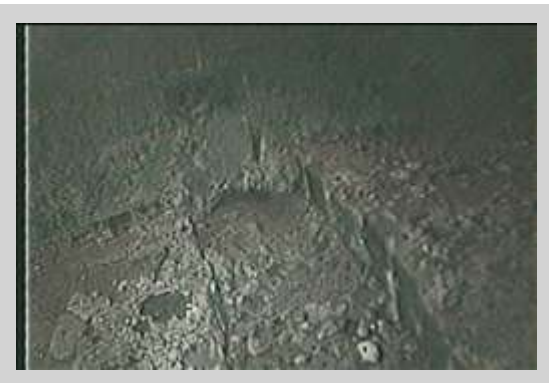
Pipe In @ 5 O'Clock

Deposits: ☐ None ☐ Mud ☐ Sludge ☒ **Debris** ☐ Grease

Silt Depth: **8** (in.) Deposits Extent: **Heavy**

Connects To: **Stub connection / abandoned**
